# Manhole Inspection Summary

Manhole # S09KK\_009MH

**Location** Address: **2001 HILTON ST**

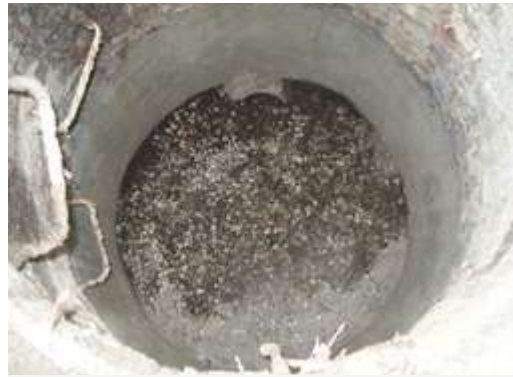
Top View

FRAME OFFSET

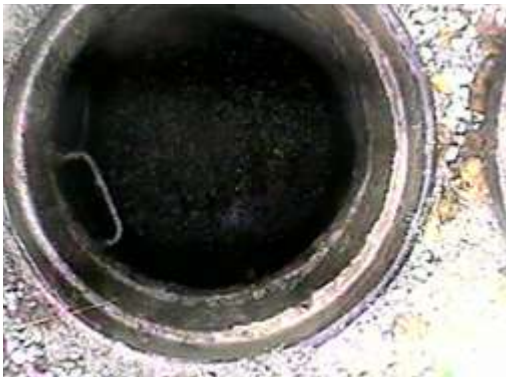
Top View

FRAME OFFSET

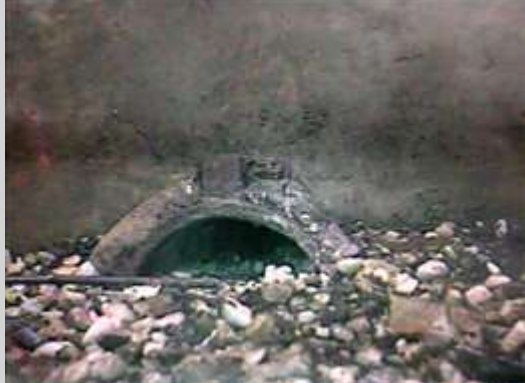
12 O'Clock Outflow

8 in. Circular Gravity Sewer  
Pipe Out @ 12 O'Clock

Deposits: ☐ None ☐ Mud ☐ Sludge ☒ **Debris** ☐ Grease

Silt Depth: **6** (in.) Deposits Extent: **Medium**
